Technical Information

CSES-ID: **TNEU1600101EN**

Product: Zeus S, Minerva S BK

ZEUS S MFPB repair procedure "Error Codes C-D011 / C-D050 / C-FA14"

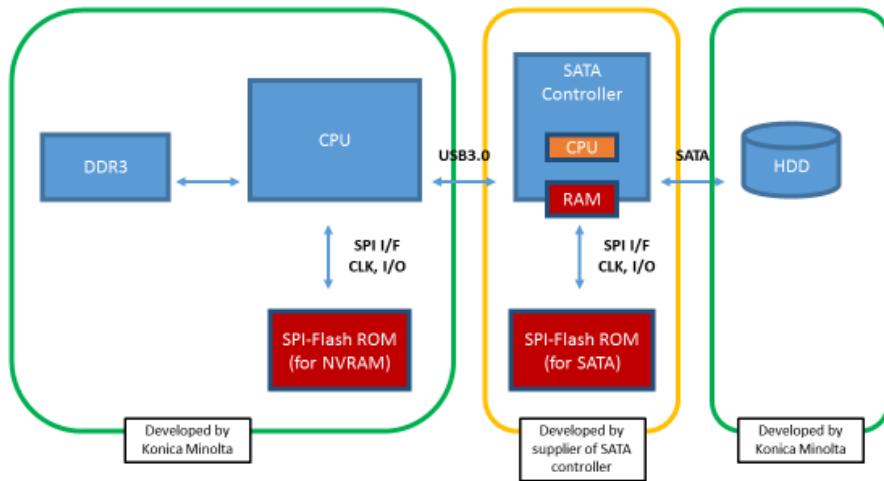
Block Diagram of MFP controller

The garbled SATA Controller data problem has been identify as a problem in the SATA controller firmware. Which is caused by wrong treatment of SPI-Flash ROM of SATA controller. The problem appears when the following situation happens.

The SATA controller loads the SATA controller firmware from SPI Flash ROM, when main power switch will be turned on or when the device is recovering from power save mode. When detecting Secondary HDD is not installed, “0x00” value is overwritten into some area of the SPI-Flash ROM of SATA controller. This processing is not guaranteed by the SPI-Flash manufacturer and causing the discharge from memory portion gradually and leads into corrupted or garbled data in SPI Flash ROM od SATA controller. In case that the SATA Controller data are garbled a hash error will occur during program loading and the SATA controller switches to run in maintenance mode. (Under normal condition the SATA controller is running in normal mode). In case the controller is running in maintenance mode the firmware treats that in this condition a non-KM HDD is connected and an error code will be shown.

As permanent countermeasure KMI provides a new SATA Controller firmware A7AH0Y0-6403-G00-04. This program can be updated by use of below firmware that only updates SATA Controller firmware

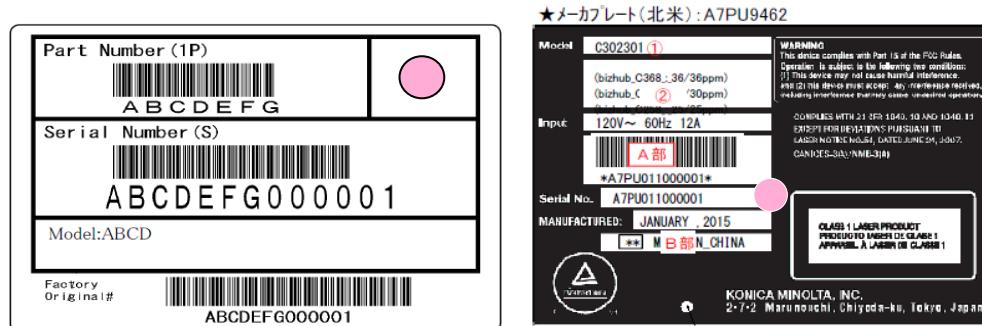
The pink dot will be added to box and machine label to indicate the updated devices

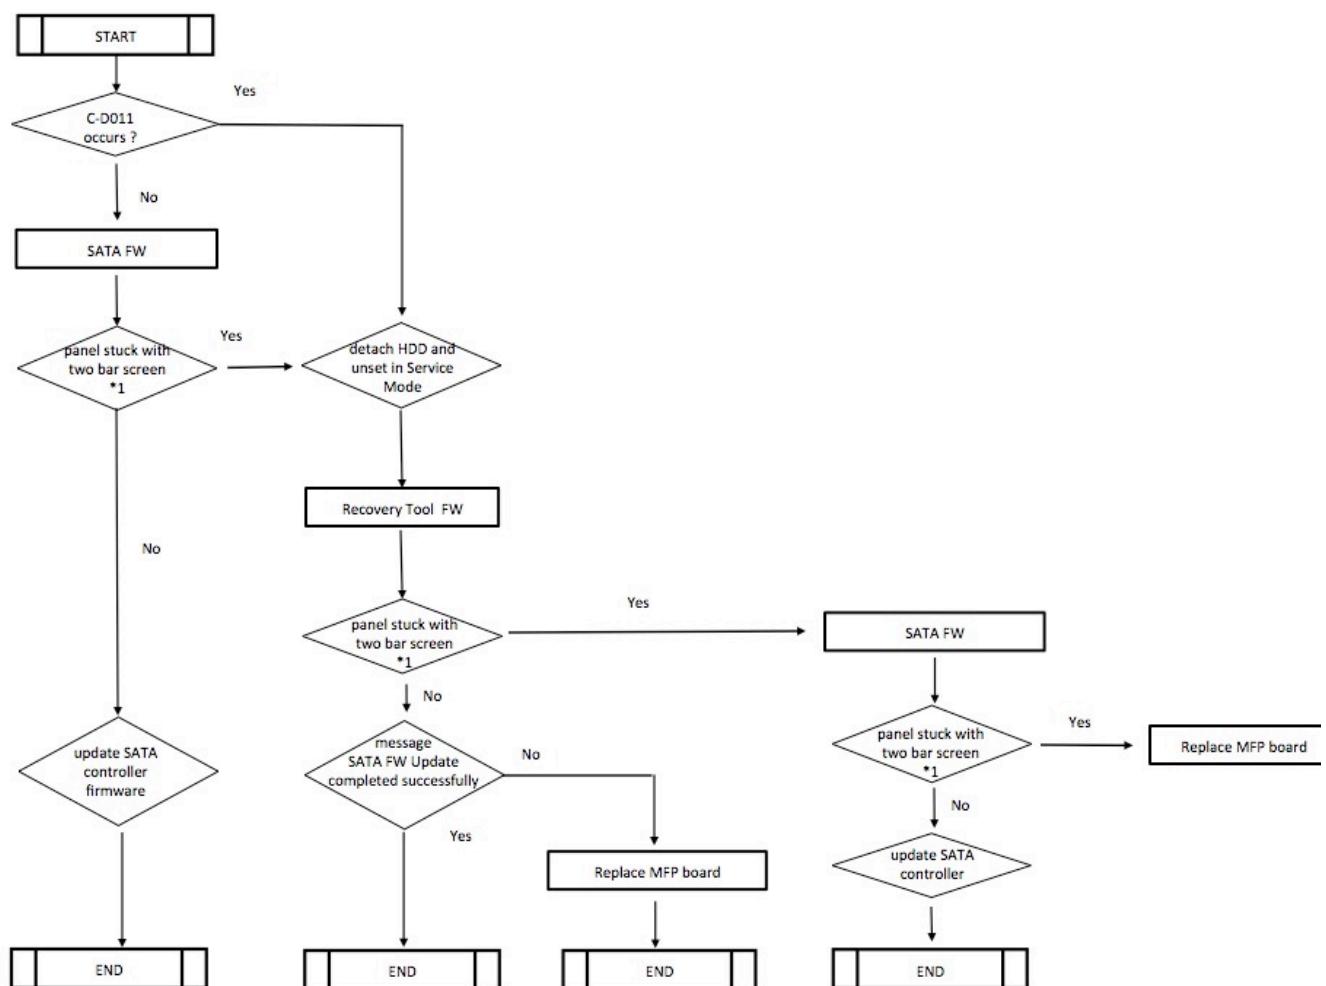
*1 note panel stuck should be detected after round about 3min

*2 note If successful update of SATA Controller firmware ends with C-D011 again , please refer Service Manual for other reason

1. Confirm the main switch is OFF
2. Insert the <**USB-SATA FW**> USB memory into USB slot.
3. Turn Main SW ON while pressing the "Stop" button.
4. **"firmware update screen."** is shown
5. Touch " **Other FW Update**" button
6. Touch " **SATA Controller**" button
7. Touch "Start" button
8. After update is completed, turn the main SW off/ on
9. Please check that new version of SATA Controller FW is now **A7AH0Y0-6403-G00-04**

1. **Detach HDD and set in Service Mode HDD = unset**
2. Confirm the main switch is OFF
3. Insert the <**USB-SATA recovery**> USB memory into USB slot.
4. Turn Main SW ON while pressing the "Stop" button.
5. After approximate 2 min message "**SATA FW Update completed successfully**"
6. turn the main SW off/ on
7. Please check that new version of SATA Controller FW is now **A7AH0Y0-6403-G00-04**
8. In case of stuck at two bars, please use SATA Controller update firmware
9. In case of "**SATA FW Update completed Failed.**" Replace MFP board
